# HISTORIC PROPERTY INVENTORY FORM

**Field Site No.** 3708 **OAHP No.** \_\_\_\_\_ **Date Recorded** 12 Oct 1994  
**Site Name Historic** Transuranium Pilot Plant **Revised** 3 June 1997  
**Common** Radioanalytical Laboratory  
**Field Recorder** M.E. Crist, K.A. Simmons, I.C. Lindsay  
**Owner's Name** U.S. Department of Energy, Richland Operations Office  
**Address** P.O. Box 550  
**City/State/Zip Code** Richland, WA 99352

**HISTORIC PROPERTY INVENTORY FORM**  
**Building 3708** (Continuation Sheet 1 of 1)

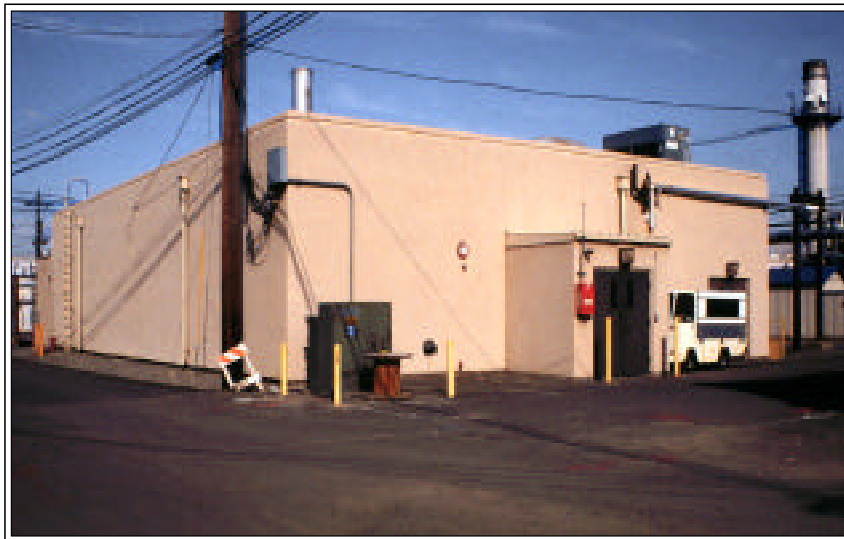
Photo at right: Roll 170, frame 23  
View of south and west facades

Building 3708 is a rectangular, one story, concrete block structure measuring 74.5 feet long by 51.16 feet wide on a north-south axis. The building sits on a concrete foundation and has no windows. Stucco covers the exterior plywood panels that cover the original concrete block walls. The main entrance is through a vestibule on the south wall. Another set of doors on the southeast corner leads to the building's equipment room. The heaters, water treatment and air conditioning equipment, air compressors, vacuum pumps, and other maintenance equipment are shut down but are still inside the room. The major renovation of the building in 1984 (Project D-342) included restructuring of interior walls and the installation of fume heads and laboratory casework. Large gloveboxes used by Douglas United Nuclear to put nickel cladding on fuel target specimens in one of the laboratory spaces were removed the previous year to prepare for the renovation. The restrooms and change rooms in the southwest corner of the building were also modified to accommodate the renovation. The equipment room in the southeast part of the building was not modified. The interior plan of the 3708 Building since the 1984 renovation consists of a main north-south hallway down the middle of the building with three large laboratory/office spaces on each side of the hallway. Most of the equipment in the rooms was removed and the vents and utilities capped when the building was abandoned and cleaned out. Renovations to the building's exterior included the addition of the vestibule on the south wall and a covered gas storage area around an existing vestibule on the north wall. Former entrances on the west and south walls were sealed off.
